EL SALVADOR

El Gran Chaparral

2015 Investment

WATER

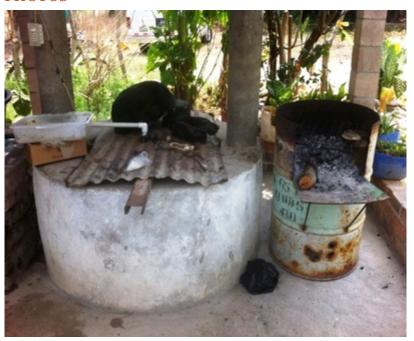
This is the well is an example of all community wells Chaparral. Most of the wells only reach a depth of 8 meters, and the water is contaminated because the people had no hygiene and sanitation training. The biggest problem is that the people lived near a sugarcane plantation where the chemicals would often reach their water source.

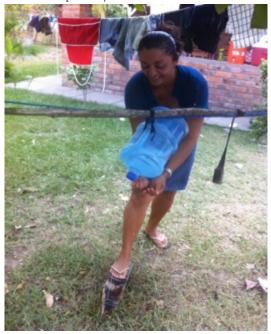
Maria Luisa Carranza, a 38-year-old community member and clothing company owner, learning how to wash hands without wasting water. Maria is using a newly-constructed tippy tap!

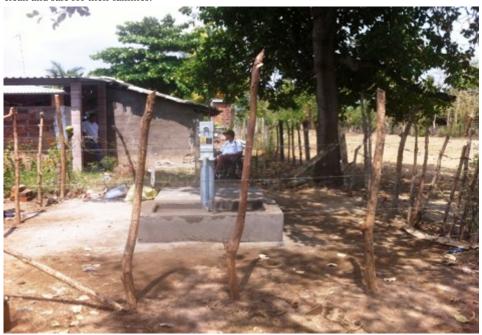
The community constructed a fence around their well to help keep livestock from contaminating the well site. The people were very proud of their new water source and committed to keeping is safe.
